Manchester-Boston Regional Airport
One Airport Road, Suite-300
Manchester, New Hampshire 03103

Addendum No. Three

RFP No: FY22-805-25 Parking and Ground Transportation Management Services

DIMENSIONS: Approximately: 300' X 767'	Area: Approximately: 1.38 Million SF
CONSTRUCTION TYPE: Hybrid – Steel Frame with and Pre-cast Concrete double T's and two cast in place concrete helices.	
BUILDING AGE: Approximately 20 years	BUILDING HEIGHTS: 6 Story
CURRENT USE TYPE: Parking Garage	OVERALL CONDITION: Good

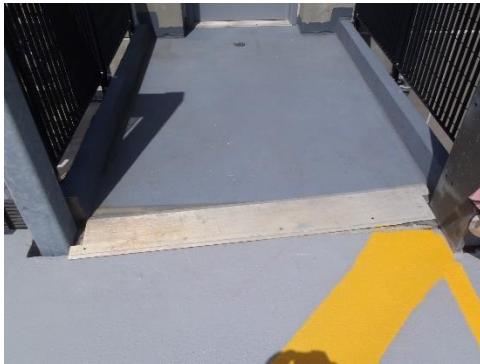
8. At stair 5 the threshold between the garage and walkway was loose and needs to be secured. *Refer to Photo 2-2.* Note there is no signage telling the floor and the stair number. *Refer to Photo 2-3.*

2-2 Stair 5 threshold not secured

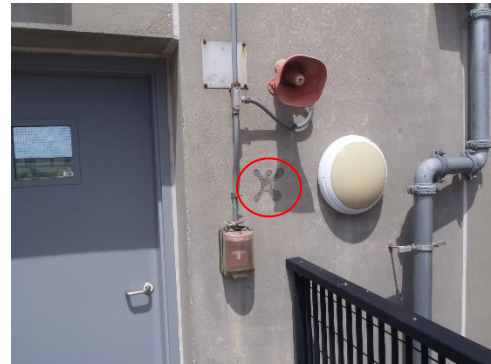
2-3 Stair 5 note no signage at door

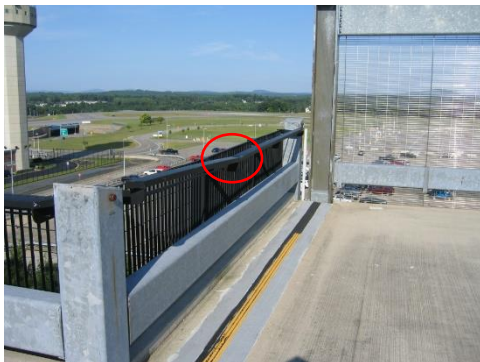
9. On the western side of the garage at the indent there is a significant dent in the top rail on the northern side of the indent. The section of the rail should be replaced. *Refer to Photo 2-4.*

2-4 Dents in top rail west side of garage

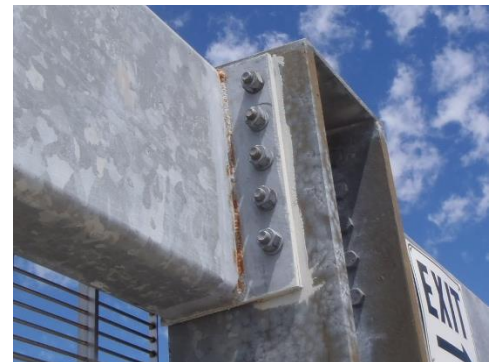
2-5 Typical rust on welded connection

10. At several locations on the perimeter of the building it was noted that the welds between the beams and end plates had surface rust on them. These locations should be cleaned and repainted. *Refer to Photo 2-5.*

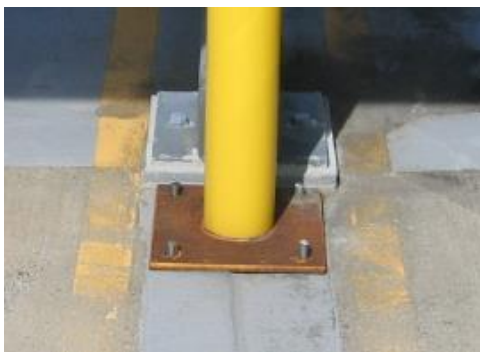
18. It was noted that some of the solar panels have different sized base plates. A total of 12 different base plate configurations were observed.
19. Some of the base plates for the solar panels area located so that they startle a joint in the precast deck panels. These connections should be reviewed to insure they are structurally adequate. *Refer to Photos 2-6 and 2-7.*

2-6 Solar panel base plate startling precast seam

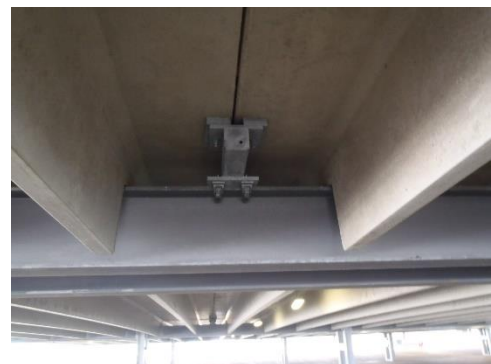
2-7 Connection on 5th level below photo 2-6

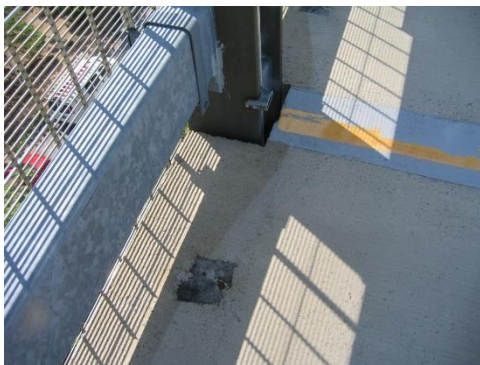
2-8 Rust at lifting pocket

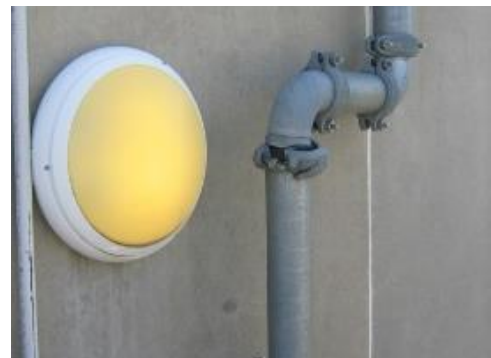
2-9 Broken conduit connection at stair 1

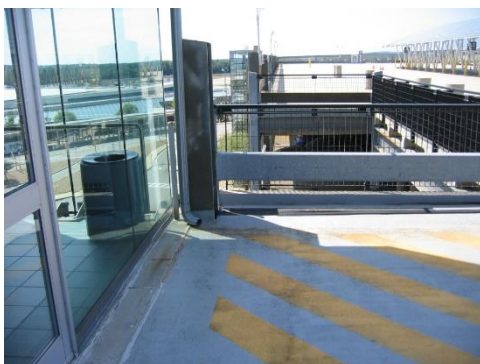
25. At the elevator (stair 2) tower it was observed that the down spouts from the roof of the tower discharges at the joint between the garage and the tower. A segmented cover plate has been installed over the expansion joint. At the southern end, this cover plate is loose. *Refer to Photo 2-10.* The cover plates should be removed and the expansion joint repaired.
26. On the northern and southern ends there is an elbow on the discharge which directs the water slightly away from the joint. *Refer to Photos 2-10 and 2-11.* At both locations the discharge points should be moved away from the joint. In its current configuration there is a significant danger of ice forming near the stair tower doors during the winter conditions.

2-10 Southern down spout from stair tower

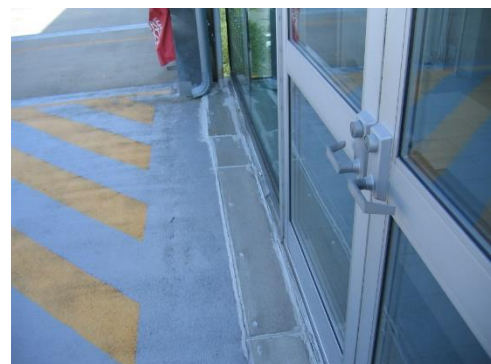
2-11 Northern down spout from stair tower roof

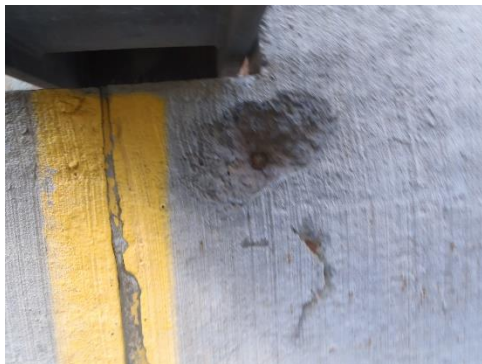
2-12 Spall in precast deck

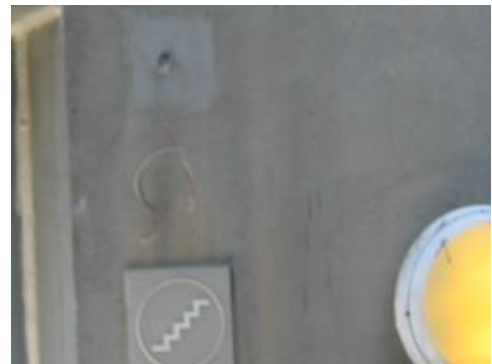
28. On the 5th level it was observed that some of the structural steel welds at the underside of the 6th floor deck, have slight surface rust on them. These areas should be cleaned and painted.
29. There is backer rod hanging out of the joints in the 6th level deck. This material should be removed, and the joints investigated for deterioration.
30. At the indent on the west side, the filler in the lifting pockets has deteriorated and there is rust showing. These pockets need to be refilled.
31. On the west side at the fourth column south of stair tower 4 there is a small spall in the precast deck that should be repaired. *Refer to Photo 2-12*
32. At stair tower 4 the fire alarm strobe light is missing and there are wires hanging out of the wall. These wires should be removed, and the strobe replaced. *Refer to Photo 2-13.*

2-13 Wires from fire alarm strobe hanging out of wall.

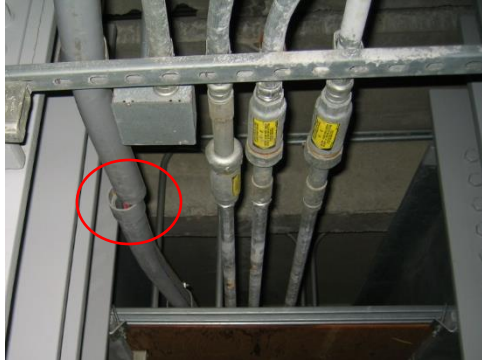
49. On parking line C at the column south of the walkway to stair tower 2 there is a PVC conduit that has separated at a joint. This appears to be due to the lack of expansion joints in the conduit. This joint should be repaired, and expansion joints installed. *Refer to Photo 2-14.* There are expansions in the other conduits at this location.

2-14 PVC conduit joint pulled apart

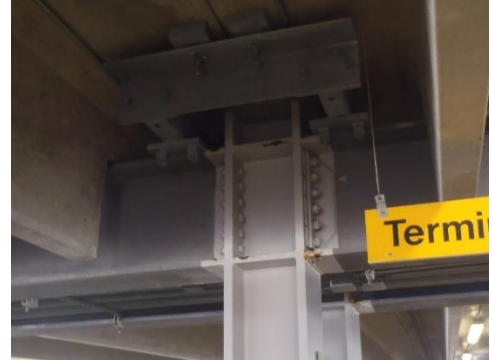
2-15 Typical solar panel anchor at precast joint with column

50. Photo 2-15 shows a typical anchor for the solar panels on the 6th level at a location where there is a column at the precast joint. Also note the rust on the structural steel.

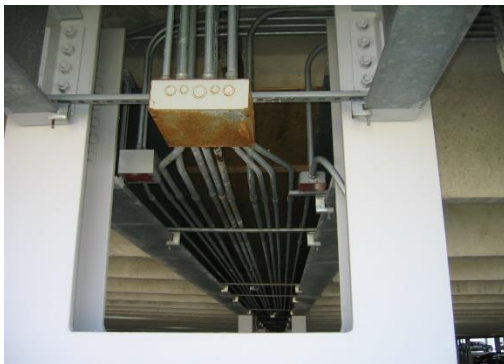
2-16 Electrical junction box rusted cover

51. Plywood has been installed between the flanges of the beams at the walkway between stairs 1 and 4. The purpose of this plywood is not known.
52. An electrical junction box at the second column south or the northern end of parking line B was observed to have a rusted cover. The connections in this box should be checked for corrosion. *Refer to Photo 2-16.*

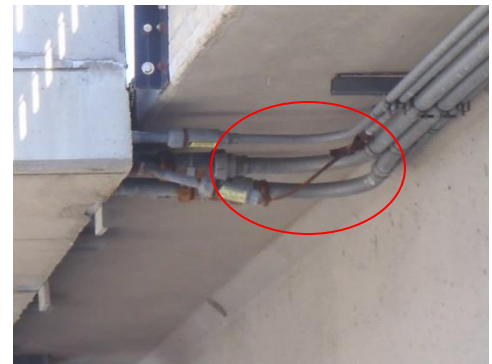
2-17 Conduit rusted through exposing wire

53. At the underside of the helix from the 6th level west side, there is a conduit that has completely rusted away. This conduit should be replaced, and the wire checked for damage. *Refer to Photo 2-17.*

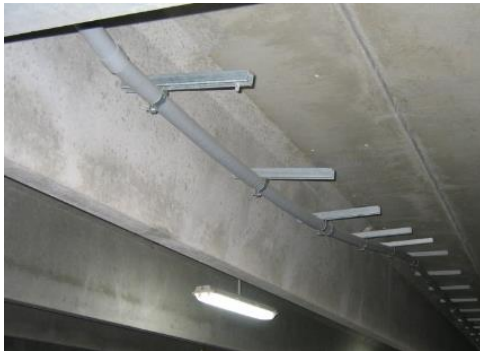
2-18 Conduit supports not fastened

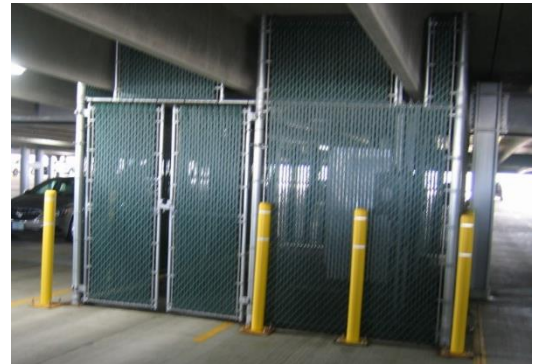
56. At the 6th column south of the northern end of parking line B five supports for the conduit running east west are not fastened to the underside of the deck and the conduit is hanging. The support should be fastened to the support the conduit. *Refer to Photo 2-18.*
57. Plywood has been installed between the flanges of the beams at the walkway to stair 2 on parking line B. The purpose of this plywood is not known. The plywood appears to be secured to the flanges of the beam.
58. There is an inverter for the solar panels located on the 9th column line north of the south end of the garage on the B parking line. The inverter is enclosed in a chain link fence. *Refer to Photo 2-19.*

2-19 Enclosure for solar inverter

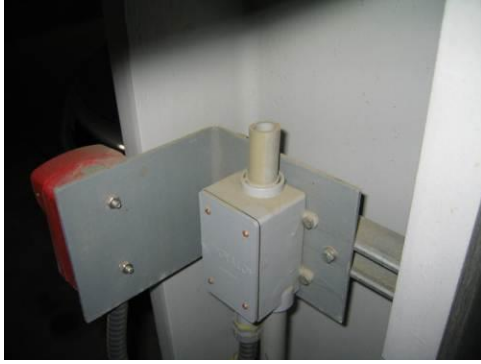
63. On the parking line A, at the 8th column line north of the southern end, there is and electrical box for the fire alarm that has an open piece of conduit at the top. This conduit should be removed, and the opening sealed. *Refer to Photo 2-20.*

2-20 Open conduit -fire alarm box

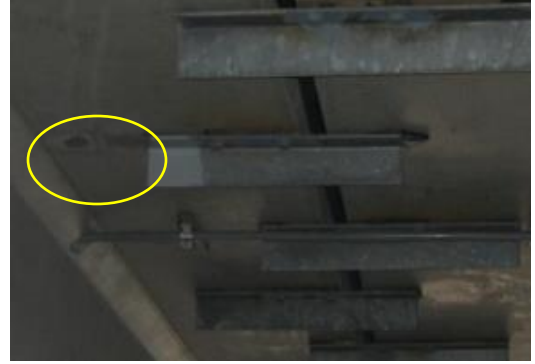
62. Some of the metal angles used on the underside of the expansion joint in the 6th level deck have been were cut back to allow for the installation of the anchors for the first solar panels. The galvanized angles were painted after they were cut. The expansion joint is located at the sixth column line north of the southern end of the garage. It did not appear that the cutting of the angles had caused any decrease in the expansion joint's capacity. *Refer to Photo 2-21.*

2-21 Expansion joint note where angle was cut to allow for old solar panel anchor

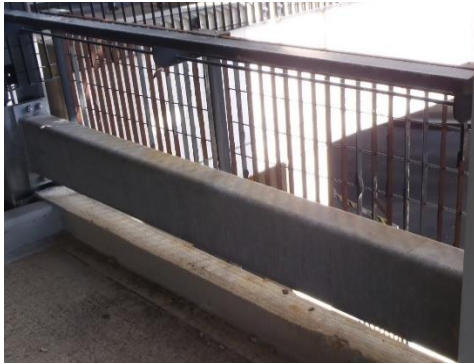
2-22 *Rusted metal screen at 4th level
southern end west side of helix*

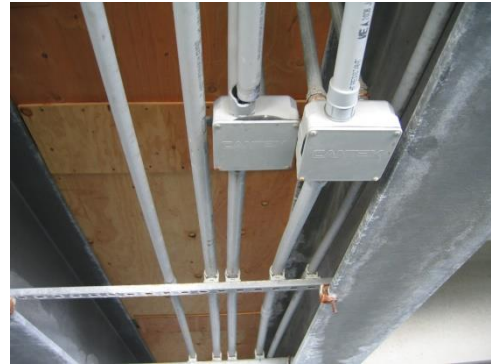
88. There is a PVC electrical junction box that between the second and third column north of the southern end that is disconnected from the conduit and the connection on the box is broken. This box should be replaced. *Refer to Photo 2-23.*

2-23 *Damaged PVC electrical box and
disconnected conduit*

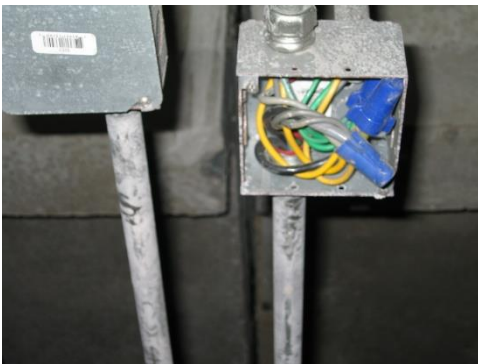
2-24 *Open electrical box with exposed
wires*

90. Between columns 10 and 11 on the C parking line there is an electrical box with no cover and exposed wires. A cover should be installed on this box and the wires should be checked for corrosion. *Refer to Photo 2-24.*

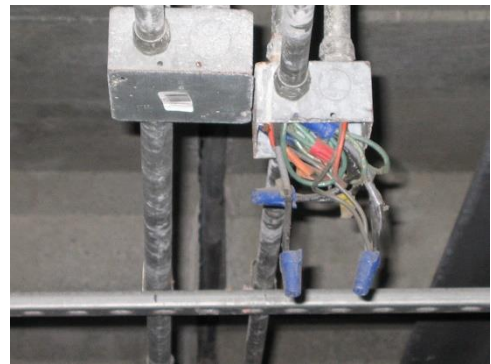
2-25 *Open electrical box with exposed
wires*

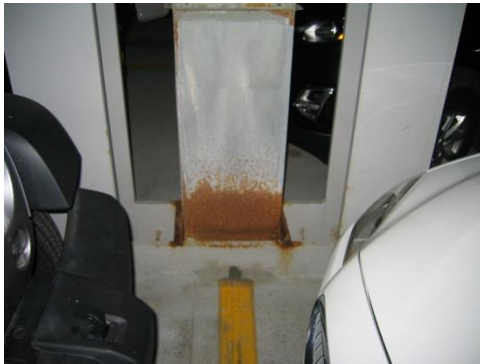
2-26 *Rusted duct work*

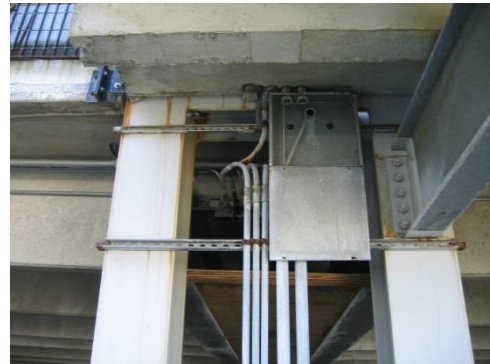
95. At the northern end of the garage there is a junction box that appears to be for communications that is open and needs to have the cover reinstalled. *Refer to Photo 2-27.*

2-27 *Open junction box*

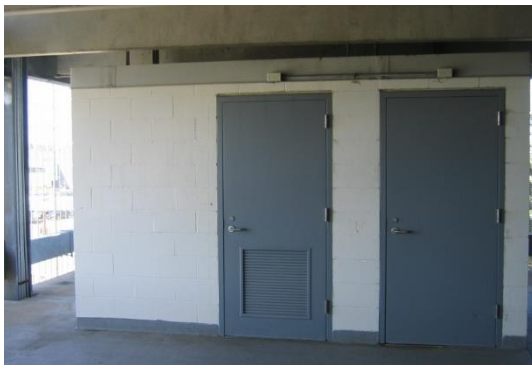
2-28 *Louver in electrical room door*

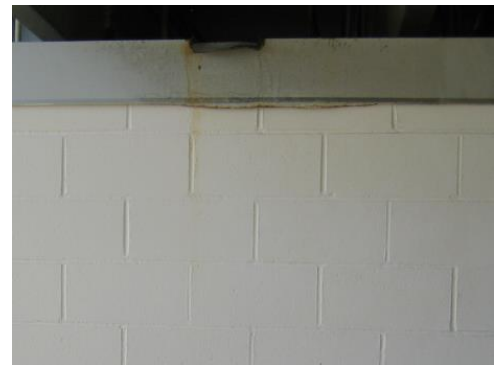
110. There are two electrical rooms on the 3rd level. One at the northwest corner and the second at the south end to the east of the helix. These rooms have the same issues as previously noted: It was observed that one of the doors on the rooms has a louver in it. We were not able to determine if this door was directly connected to the electrical equipment room. If the door with the louver is connected to the electrical equipment room, then the door must have the same fire rating as the room. This condition was observed at all the electrical rooms in the garage. There was also rust on the ventilation louvers in the wall which should be cleaned and repainted or replaced. *Refer to Photo 2-28.* The southern electrical room has a rusted scupper on the eastern end and there is rust on some of the conduit on the roof. *Refer to Photo 2-29.*

2-29 *Rusted scupper southern electrical room east side.*

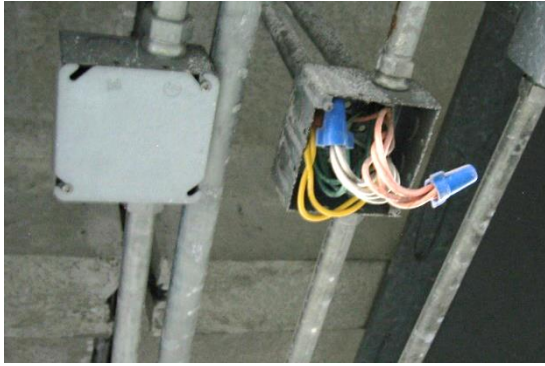
123. Between the 6th and 7th column south to the northern end of the garage on the C parking line there is an open electrical box with exposed wires. The wires in this box should be checked for corrosion and a cover installed. *Refer to Photo 2-30.*

2-30 Open electrical box with exposed wires

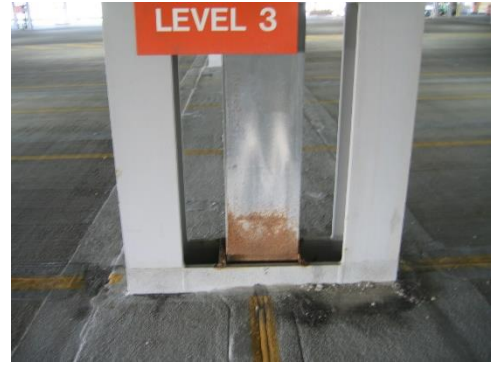
2-31 Rusted ductwork at floor level

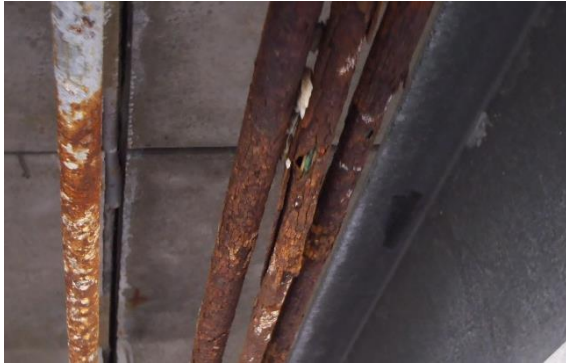
126. The conduit that runs on the C parking line the length of the garage has several locations where it has heavy rust. This conduit should be inspected and any conduit that is rusted through should be replaced. *Refer to Photo 2-32.*

2-32 Conduit rusted through

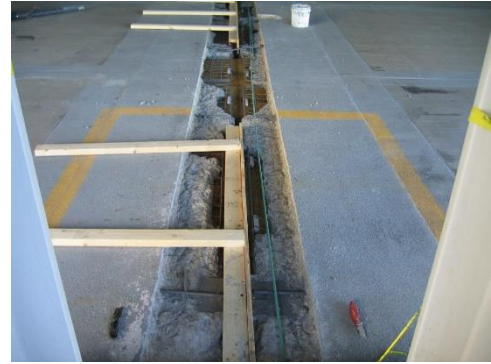
2-33 Concrete repair on C parking line

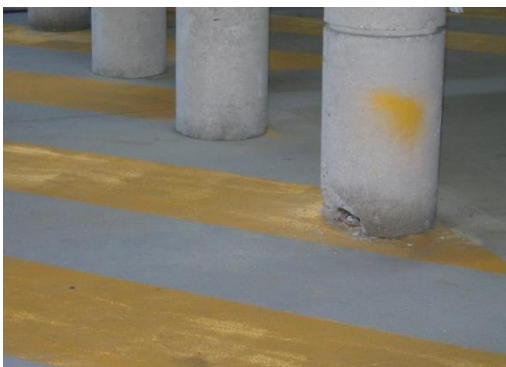
2-34 Damage concrete bollard typical

141. There is damage to the concrete bollards throughout this level that should be repaired. *Refer to Photo 2-34*

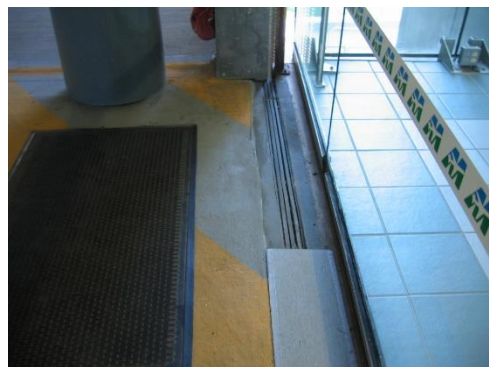
2-35 Expansion joint cover plate removed stair

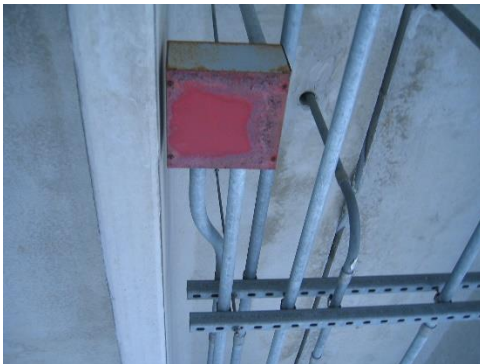
151. At the northwest corner of the garage there are several conduit penetrations that are not fire stopped. *Refer to Photos 2-36 and 2-37.* All openings to the third level electrical room should be properly fire stopped. There is an electrical box on the north side of stair 4 that has heavy rusting and should be replaced.

2-36 Electrical conduit northwest corner

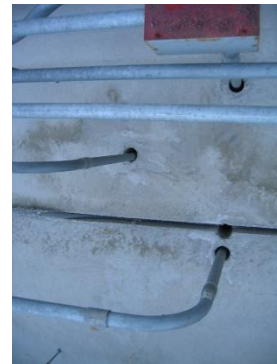
2-37 Close up of openings without fire stop

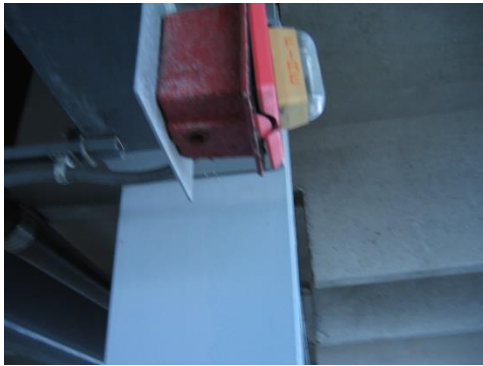
152. At the 10th column north of the southern end of the garage there is a fire alarm strobe light that is broken at the bottom. This strobe should be replaced. *Refer to Photo 2-38.*
153. On the D parking line at the 8th column north of the southern end of the garage the 4” vertical drain line, labeled “sanitary drain” is split. These drain lines need to be replaced and the lines cleaned. *Refer to Photo 2-39.*
154. At the southern end of the D parking line there is an electrical junction box that has mild surface rust which should be cleaned and repainted.
155. At the 2nd level, the black metal screening on both sides of the southern helix have lost most of their finish and have heavy surface rust. These pieces should be cleaned and refinished or replaced. *Refer to Photos 2-40 and 2-41.*

2-38 *Damaged fire alarm strobe*

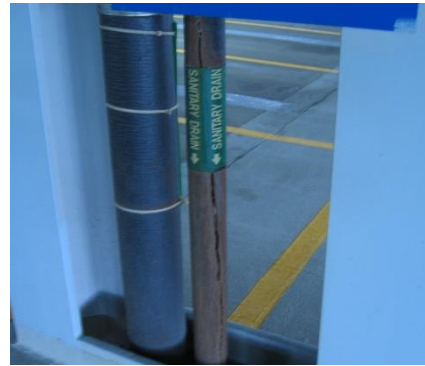
2-39 *Split vertical drain pipe*

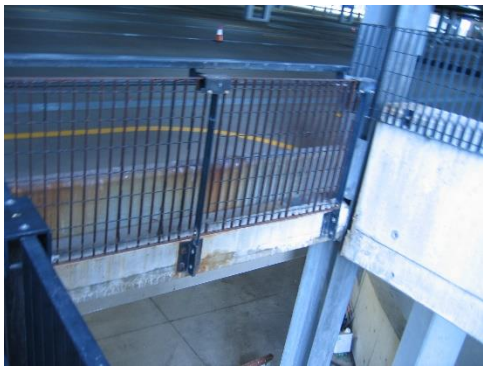
2-40 *Rusted metal screen at 2nd level
southern end west side of helix*

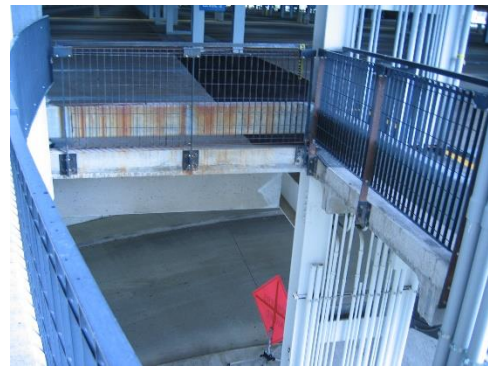
2-41 *Rusted metal screen at 2nd level
southern end east side of helix*

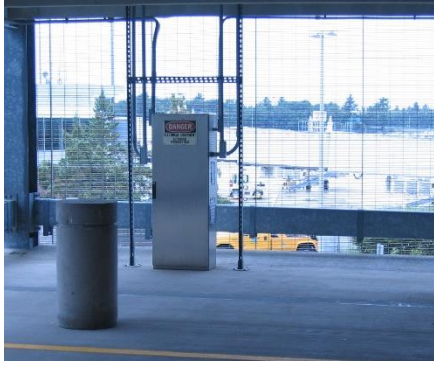
171. At the southeast corner of the second level there is a piece of electrical equipment. On the west side of this equipment there are two holes large enough to put a hand into. The openings have been covered with duct tape. These opening should be properly covered with a metal plate. *Refer to Photos 2-42 and 2-43.*

2-42 Electrical equipment south east corner

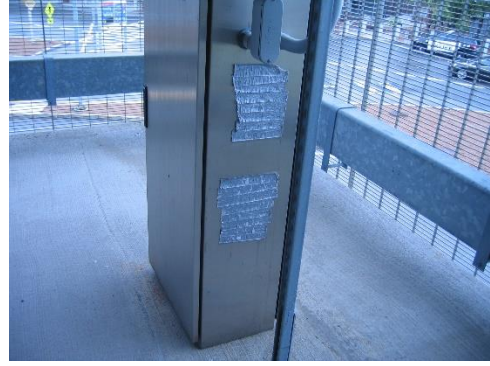
2-43 Opening in side of equipment covered with duct tape

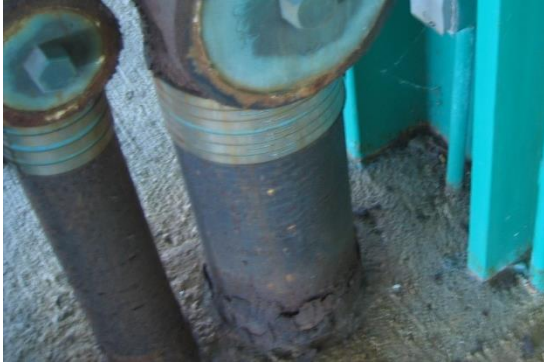
2-44 Corrosion at base of drain pipe

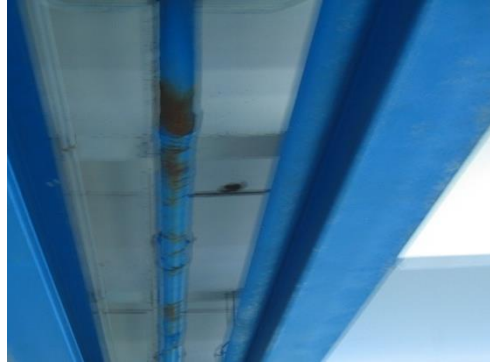
2-45 Corrosion on drain line

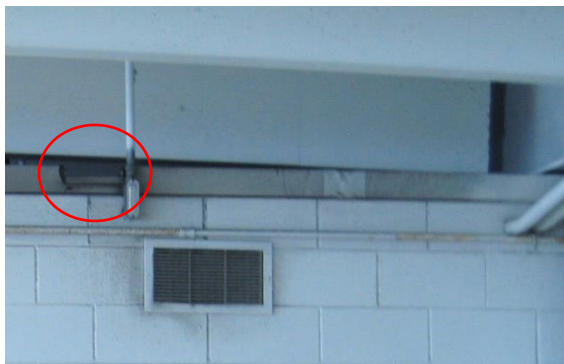
188. On the south side of National Garage office, it was observed that the electrical conduit that enters the wall below a roof scupper. This scupper should be moved away from the electrical wall penetration and lengthened to project any water out over the conduit below. Refer to Photo 2-46.

2-46 South side of National Garage office note electrical line at roof scupper

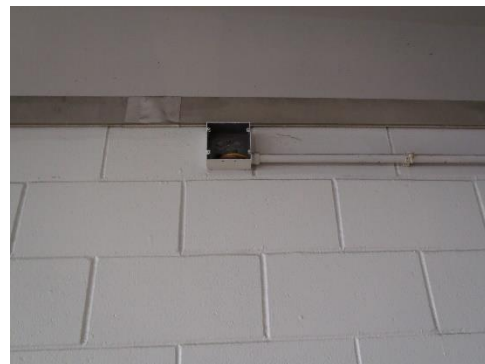
2-47 Open electrical box on south side of National Garage office

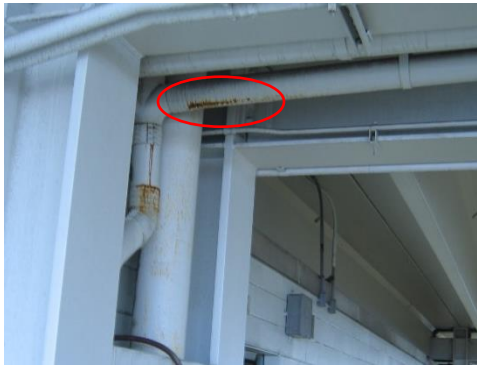
2-48 Cracked drain line

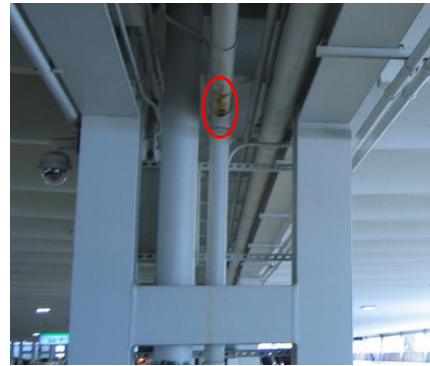
192. There is a cracked drain line at the 10th column south of the northern end of the garage. This drain line should be cleaned and repaired *Refer to Photo 2-49.*

2-49 Cracked drain line at 10th column

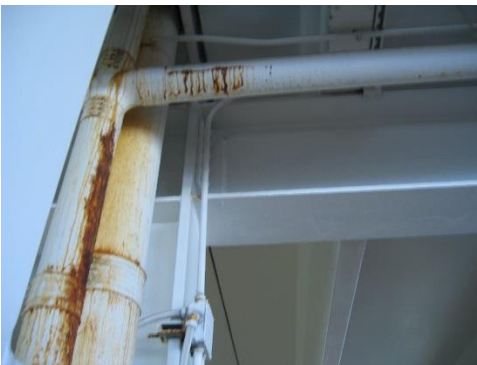
2-50 Crack in drain line

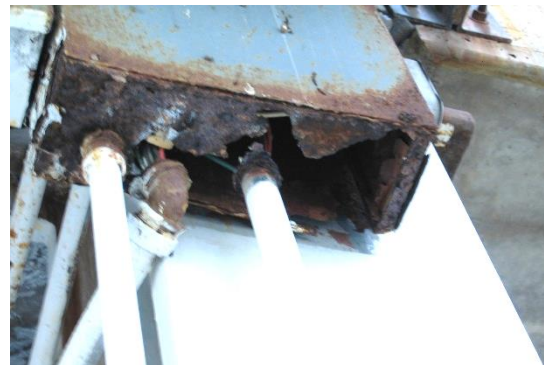
2-51 Deteriorated electrical junction box

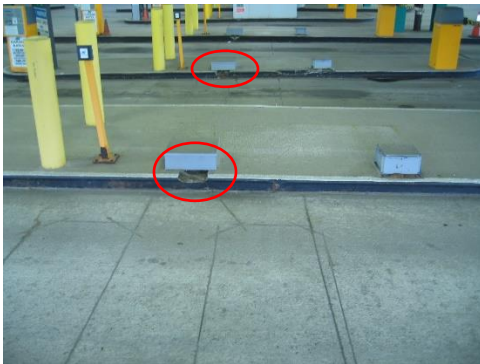
204. There are gray boxes on the islands between column lines D and C. At some of these boxes there is a hole in the concrete island which could pose a trip hazard. Install a cover over these openings. *Refer to Photo2-52.*

2-52 Opening in concrete island

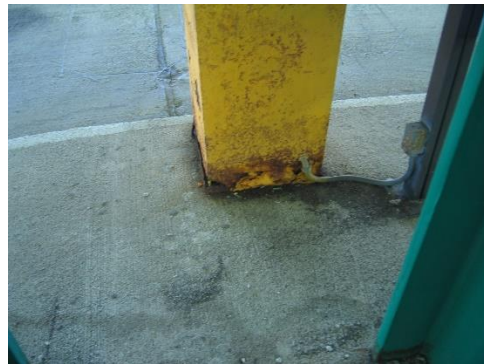
2-53 Typical rusted toll gate

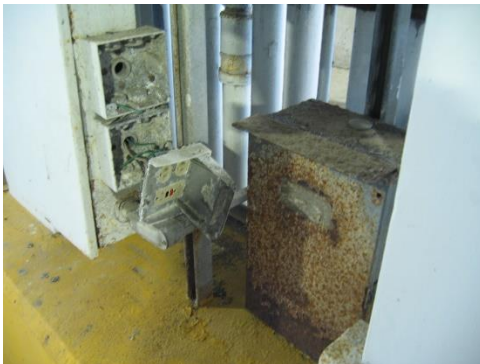
2-54 *Rusted disconnects*

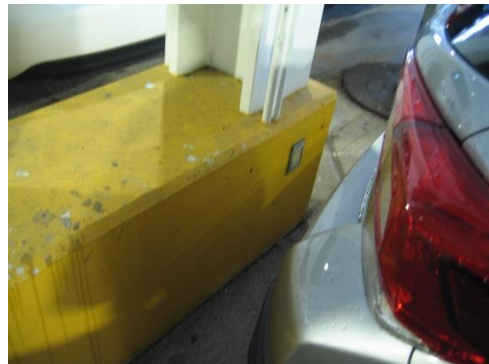
2-55 *GFCI outlet missing weather cover*

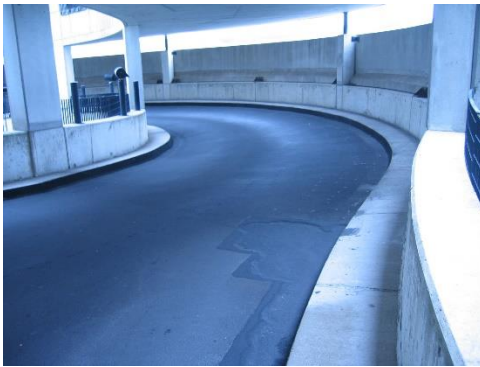
2-56 Repair in traffic coating 3rd level

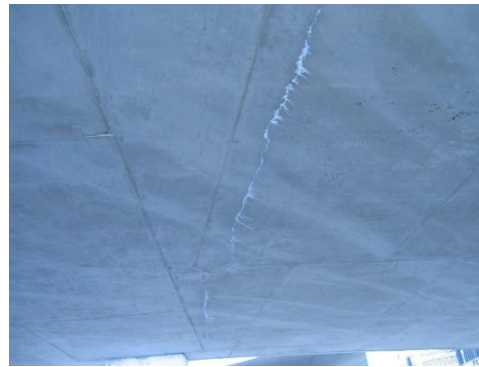
2-57 Crack with efflorescent in ceiling of helix

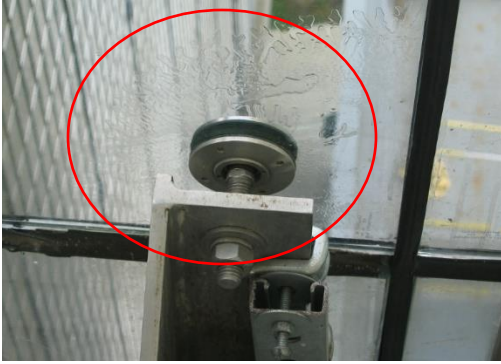
1. The gaskets on the glass wall of the elevator lobby were observed to be loose at several locations. At one location where the glass is connected to the structural steel there appeared to be delaminating glass. *Refer to Photo 2-58.*
2. There is a crack in one of the glass wall panels on the southern side of the elevator lobby on the 6th floor. This panel should be replaced.

2-58 Apparent delaminating of glass wall north side of 6th level elevator lobby

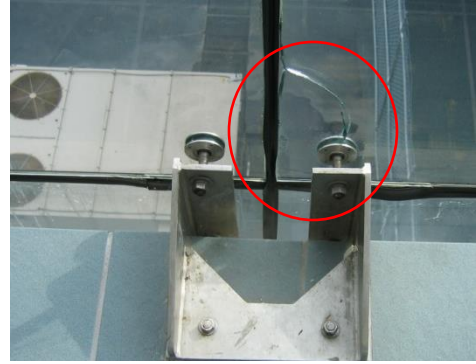
2-59 Crack in glass wall panel south side of 6th level elevator lobby

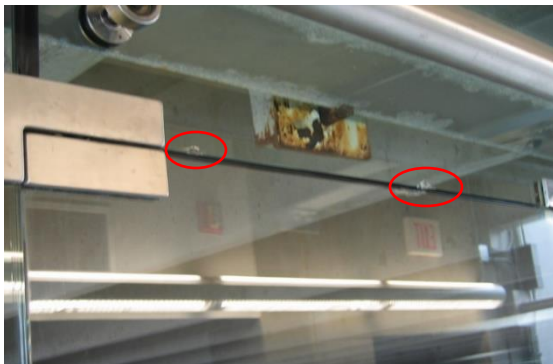
3. At the elevator lobby on the 5th level there is rust on the steel above the doors and at the southwest corner of the ceiling. The glass on the doors and the glass above the doors have several chips. The thresholds on the doors are also damaged and appear to be holding one of the doors open slightly. The back of the exit sign on the garage side of the wall has moderate surface rust that should be removed and repainted.
4. At the fourth level there are chips in the glass at the top of the door and the glass above the doors. Refer to Photo 2-60.
5. Rust was observed on the steel beams, above the doors, that support the 5th level. This rust needs to be removed and the beams painted. The source of the water should also be investigated further, and repairs made as needed.

2-60 Chip in glass above door

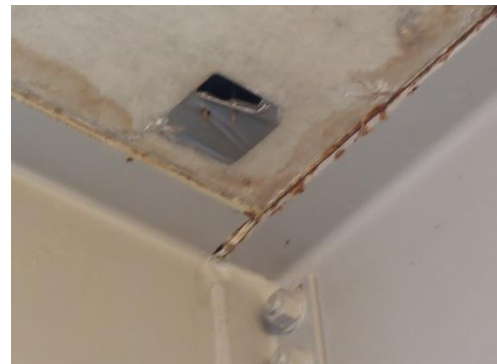
2-61 Electrical box at northwest corner.

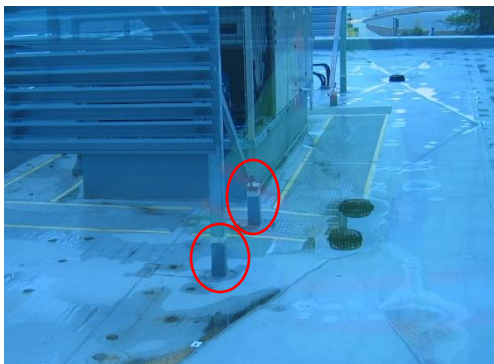
1. The flashings on the tube column screen supports on the roof do not appear to conform to typical manufactures specifications. This detail should be verified and corrected if not in compliance.
Refer to Photo 2A-2.

2A-2 Air handler screen support flashing

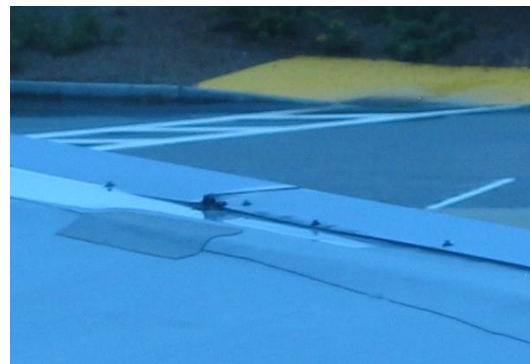
2A-3 End joint in roof edge flashing
