Manchester-Boston Regional Airport
One Airport Road, Suite-300
Manchester, New Hampshire 03103

Addendum No. Three

RFP No: FY22-805-25 Parking and Ground Transportation Management Services

DIMENSIONS: Approximately: 300' X 767'	Area: Approximately: 1.38 Million SF
CONSTRUCTION TYPE: Hybrid – Steel Frame with and Pre-cast Concrete double T's and two cast in place concrete helices.	
BUILDING AGE: Approximately 20 years	BUILDING HEIGHTS: 6 Story
CURRENT USE TYPE: Parking Garage	OVERALL CONDITION: Good

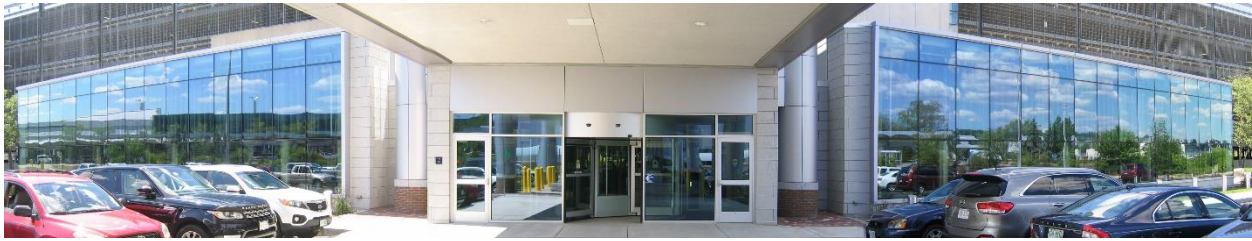
2A-1 Exterior view East side

The rental car customer service facility is located on the east side of the parking garage at the first level. Constructed was completed in 2016. The building is used by the rental car companies to service their customers and as office space for the staff. The building was found to be in new condition.
